## Research on Epoxy Repaired Reinforced Concrete Beams

By Dr. Mehmet Ce1ebi\*

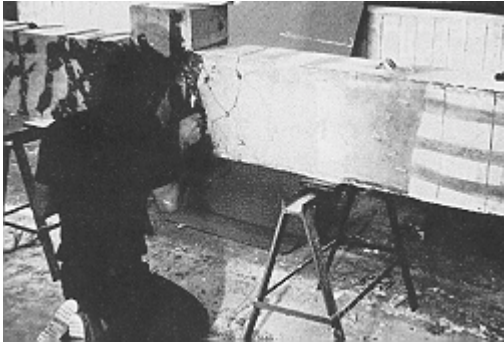
Fig. 1

The epoxy repairing process was applied professionally on the test specimens by a specially trained and licensed crack injection contractor. The sealing process (Fig. 1) consists of first cleaning the surface of the specimens to be repaired. All loose concrete particles are removed and dust is blown off.

Masking tapes and nails for injection holes are placed at prescribed locations. A fast setting epoxy adhesive is applied to seal off the cracks; when it hardens, the tapes are lifted off. These locations are later used as checking (bleeding) points.

The very fast setting "slump-pumping" liquid epoxy adhesive is injected into the specimens by an automatic mixing pump at pressures up to 250-300 psi. The epoxy penetrates the cracks and outflows (bleeds) from the predetermined bleeding points. The process is continued until all cracks are penetrated fully. About 24 hours later, the sealing surface epoxy is ground off to restore the smooth surface.

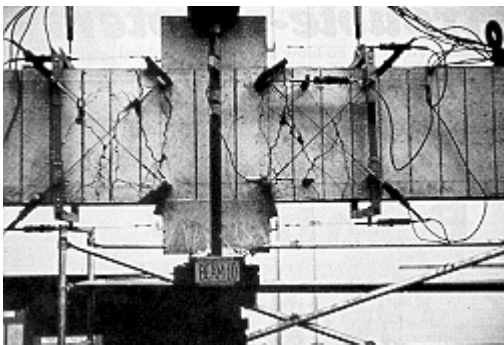
Fig. 4

To test the specimens, the EERC testing facility was used with the test frame in Fig. 3. One of the specimens repaired and tested is Beam 10, shown before repair (Fig. 4). This beam was tested according to a preplanned, triangularly shaped (constant velocity-0.1 in/sec) displacement scheme. The load deflection hysteresis loops of the original beam are seen in Fig. 5. (Note: Figs. 5 and 7 are on the next page.)

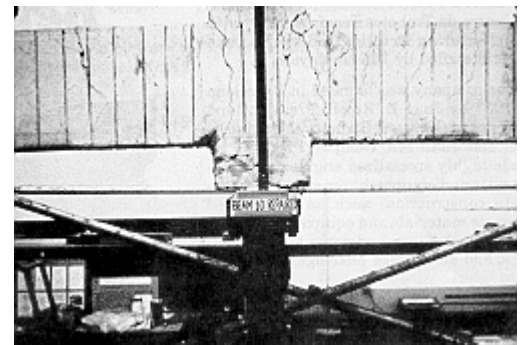
Fig. 6 shows the state of the repaired

Beam 10 after repairing and testing with the same displacement scheme and velocity as the original beam. The hysteresis loops of the repaired beam are seen in Fig. 7.
