**PROJECTS REVISITED:  
Ferry Building, S. F.**

**The project-1967.** The Ferry Building on San Francisco's Embarcadero was constructed in 1896 and has always been one of the city's more notable attractions. Facing out over San Francisco Bay and the business district of the city is the 6-story, 4-sided clock tower which was modeled after a famous tower in Spain. Until 1958, the Ferry Building was the terminus for ferry boats from Oakland and Sausalito which now dock next door.

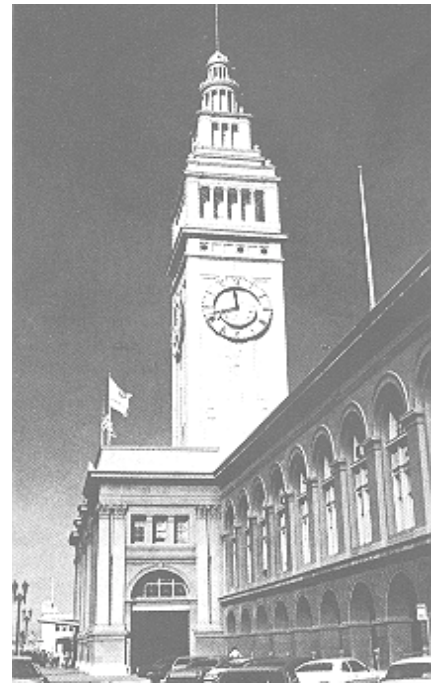
April 1975. Front view of Ferry Building illustrates excellent condition of tower walls seven years after repairs by epoxy injection.

**The outcome-1975.** In the past eight years all of the tower walls have been inspected annually as part of the Port Authority's regular preventive maintenance program. James E. Read, Materials & Research Engineer, says that since 1967 no repairs of any kind have been necessary on the walls. All injected cracks are still bonded and there is no evidence of cracking on any of the surfaces. "In that time," he adds, "we have experienced several minor earthquakes in San Francisco, but the resultant tremors and shakes have not affected the tower in any way. I would venture to say that the repaired tower probably is stronger structurally now than when it was built."

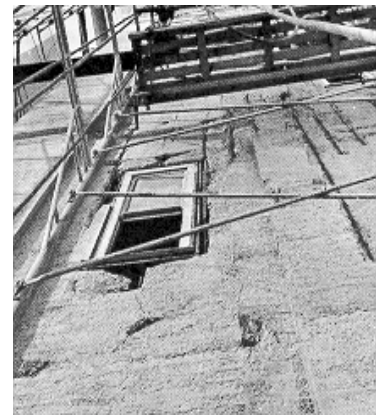
Over the years, shrinkage cracks, rain, moisture penetration, fog and salt-laden air united to deteriorate the concrete walls on all four sides, with the weathering north and east walls the most severely eroded. By 1967, the concrete walls were in extremely poor condition.

Deterioration consisted mainly of extensive spalled areas, holed-through sections, large expanses of exposed reinforcing bars, and considerable random cracking through the walls. Many of the cracks ran from one floor to the next, with more than 500 lineal feet of cracks in each tower wall. Crack widths ranged from a minimum of 0.004 in up to 0.100 in. It should be pointed out, however, that the concrete was still essentially sound.

1967. Exterior of Ferry Building prior to guniting. The concrete was 61 years old and showed deterioration caused by rain, moisture and salt air.

**The solution.** To restore the tower's exterior surfaces architecturally, as well as its overall structural strength, the San Francisco Port Authority specified: two coats of gunite on the outside walls; followed by the filling of all cracks internally using a low viscosity structural repair epoxy injection resin using automated mix pumps.

Within 24 hours after guniting, crack repairs began on several floors simultaneously, with up to four pumping machines in operation. The cured gunite acted as a firm backstop to the pressure injected epoxy adhesive.

After an epoxy surface seal was applied over the cracks on the interior, the adhesive was pumped into the crack until it oozed out at a point further along the crack plane. This process was continued until all of the cracks had been filled.

Approximately 3300 lineal feet of cracks were repaired in this manner, requiring 14 working days and 66 gal injection resin, applied at the rate of about 1 gal. per 50 linear ft. of crack. When the adhesive had cured at ambient temperature, the concrete was permanently bonded once again into a sound, monolithic structure.
