# LOS ANGELES- FEBRUARY 9, 1971 RICHTER SCALE: 6.6

## Crack Injection Saves 25 Concrete Wall Panels in Quake-Hit Building

By D. F. Moran, Structural Engineer  
Wheeler & Gray, Consulting Engineers  
Los Angeles, Calif.

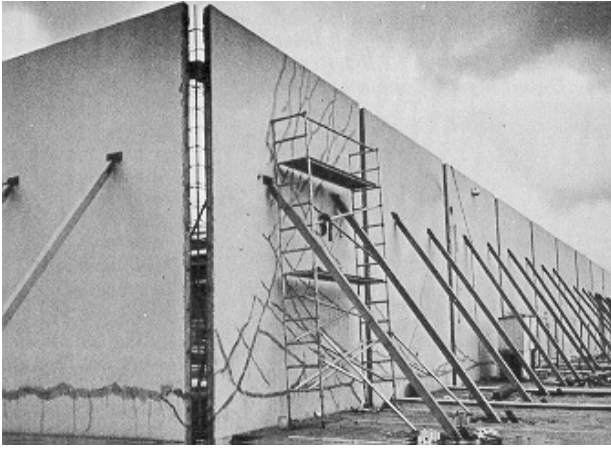
This corner panel was the most severely damaged, yet was salvaged by epoxy injection.

When the diaphragms failed, the panels and columns were required to cantilever vertically from the footings. This caused extensive cracking in the columns and panels horizontally near the ground line. Twenty-five panels were damaged by cracking, some of the cracks branching diagonally across the face. Three panels including the two that fell, had to be replaced. Only 12 were undamaged.

Some of the cracks probably were due to normal shrinkage stresses prior to the disaster. At any rate, after the earthquake there were over 1800 lin. ft. of hairline to 1/4 in. wide cracks in the 25 damaged panels.

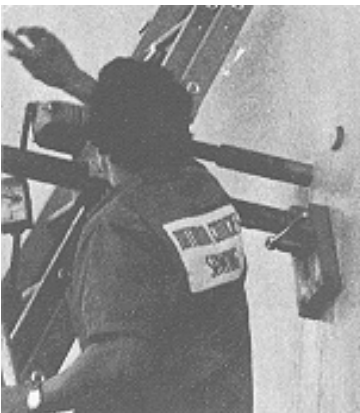
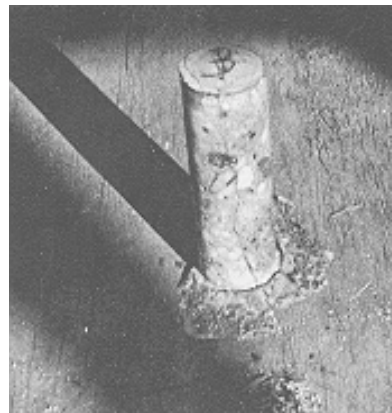
(Left). Cores for testing were taken by National Concrete Sawing Company in one panel at locations marked by the structural engineer. (Right). One of the cores, showing how the injected epoxy adhesive penetrated the cracks in the reinforced concrete of the tilt-up panel.
