Outside the collapsed Vector building, D. F. Moran (left) consults with his contracting manager, about the application of epoxy injection repairs to the 25 cracked concrete tilt-up panels.

D. F. Moran, Consulting Structural Engineer

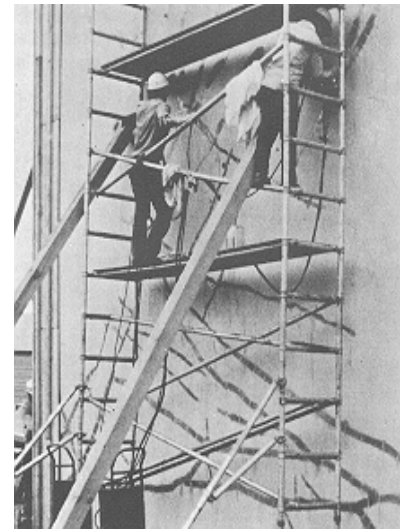
Structural injection resin is injected into cracks through ports made at intervals in the temporary seal. Pumping continues until the liquid adhesive appears at the next immediate port.

Epoxy injection proceeded in the usual manner. The fine diagonal cracks were sealed for pressure pumping by a temporary seal, and the larger horizontal cracks near the ground line with a high viscosity epoxy paste adhesive.
