Concrete Penstock Liner Damage Repaired with Crack Injection

Structural Epoxy Repairs Cracked Prestressed Beams

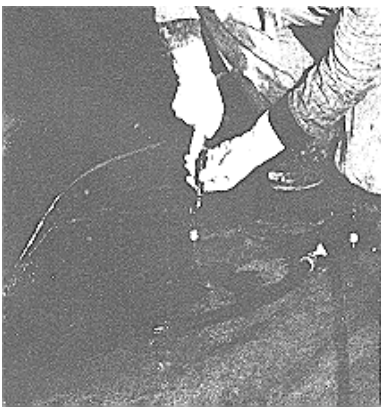
Repairing the concrete. Note discoloration marks left by the water flowing into the liner.

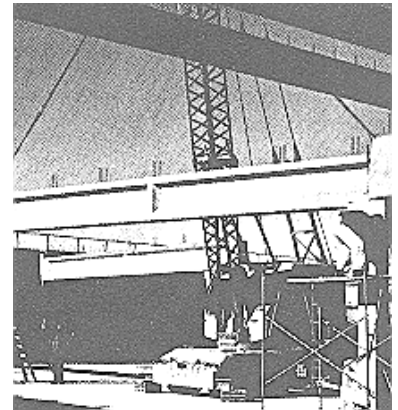
This large beam in a major Western prestressed concrete yard was successfully repaired with crack injection saving the contractor many hundreds of dollars.

In one large precasting yard, several double-T beams had developed cracks which were about 0.010 in. wide running at a 90° angle across the prestressing cables. Low viscosity epoxy injected at high pressure into the full depth of the cracks filled the voids and bonded the concrete permanently.
