**Projects Revisited—
Bonded Flume Fillets
Yuba-Bear River Project**

The projects - 1966. Two reinforced concrete bench flumes owned and operated by Nevada Irrigation District (Yuba-Bear River Project), Colfax, California, to provide water to power turbines for two hydroelectric plants owned by the District. Dutch Flat flume is 41/2 miles long, 14 ft. wide and 7 ft. high. Chicago Park flume is 31/2 miles long, 18 ft. wide and 10 ft. high. The 10 in. thick walls of the flumes are 60-ft.-long free-standing sections with water-stopped joints, and were poured monolithically with the 2 ft. thick concrete invert.

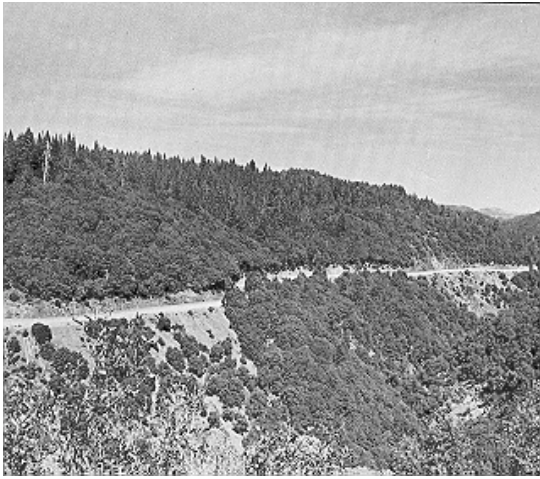
1974. A section of the 41/2-mile-long Dutch Flat flume as it looks now. The flume feeds water to a 26 megawatt powerhouse unit owned by the Nevada Irrigation District.

The outcome - 1974. The adhesive bonded concrete fillets in the Dutch Flat and Chicago Park flumes have been immersed in water and subjected to extreme surge conditions for nearly 8 years and 6 years, respectively. During those periods, according to E. G. Pretzer, Project Manager for the Nevada Irrigation District, the fillets have reinforced the outside flume walls successfully and there have been no further wall section failures.

"When the flumes are down for maintenance outages two weeks out of each year," said Mr. Pretzer, "the fillets are visually inspected for their entire length. The bond of the concrete fillet to wall and invert in both flumes still appears to be in excellent condition, and there are no signs of separation anywhere."

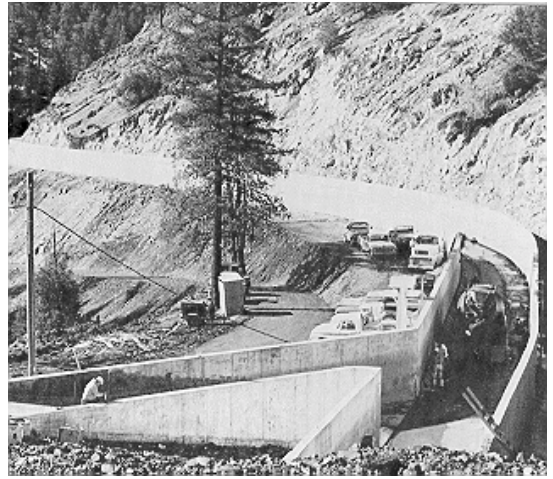
1966. All but about 10 percent of the outside wall of Dutch Flat Flume is reinforced with a concrete fillet bonded to the wall and invert.

The solution. The engineers designed a reinforcing fillet for the outside wall consisting of a poured concrete buttress to be adhesive-bonded to the wall and invert.

Reinforcement design called for drilling 41/4 in. deep holes into the wall and invert, driving concrete bolt anchors into the invert and hookbars into the wall, pressure testing the anchors to 7000#, sandblasting the concrete and reinforcing steel, erecting wooden forms, spraying a long potlife structural epoxy on concrete and steel surfaces, and placing a 2-1/2 in. maximum slump portland cement concrete with a minimum 2 in. thick concrete cover over the steel.

Over 90 per cent of the Dutch Flat flume was reinforced in that manner in 1966, with a fillet 15 in. high on the wall and 15 in. wide on the invert. Bridge sec-

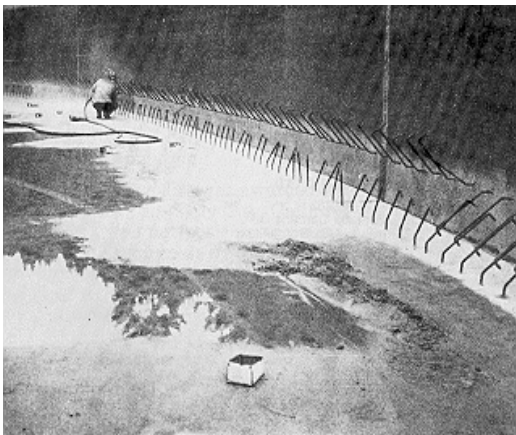
(Left) Reinforcement in the Chicago Park flume consists of 3/4-in. hookbars on 12-in. centers which were epoxy paste grouted.

The successful reinforcement of the Dutch Flat flume prompted the filleting of 5000 lin. ft. of the outside wall of Chicago Park flume in 1968, 2500 lin. ft. in 1970 and 1500 lin. ft. in 1973. The fillet in this larger flume is 20 in. high and 21 in. wide on the invert.

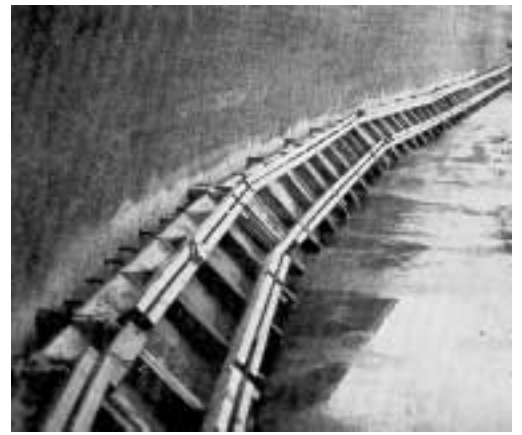
(Right) After sandblasting, wood forms were built. A very long potlife liquid epoxy bonding agent was sprayed onto concrete and steel, and a 6-1/2 sack portland cement concrete poured.
