## Research on Epoxy Repaired Reinforced Concrete Beams

By Dr. Mehmet Ce1ebi\*

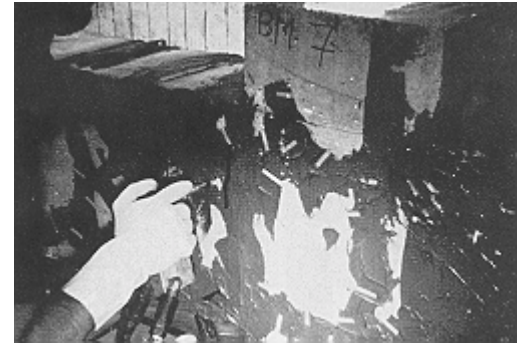
Fig. 1

The epoxy repairing process was applied professionally on the test specimens by a specially trained and licensed crack injection contractor. The sealing process (Fig. 1) consists of first cleaning the surface of the specimens to be repaired. All loose concrete particles are removed and dust is blown off.

Masking tapes and nails for injection holes are placed at prescribed locations. A fast setting epoxy adhesive is applied to seal off the cracks; when it hardens, the tapes are lifted off. These locations are later used as checking (bleeding) points.
