Concrete Penstock Liner Damage Repaired with Crack Injection

Structural Epoxy Repairs Cracked Prestressed Beams

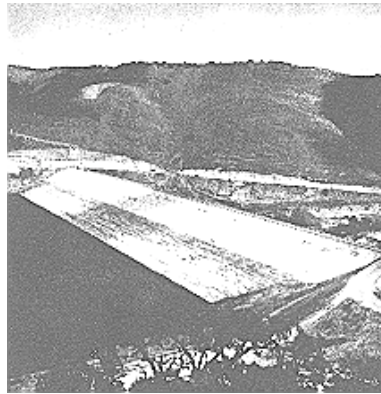
Repairing the concrete. Note discoloration marks left by the water flowing into the liner.

largely by natural sulphur deposits and raw asphaltic materials. The gas, which showed up as a frothy substance in the crack areas, was corroding the reinforcing steel in the concrete liner.

The cracks and control joints were filled in Spring 1968 with a low viscosity structural injection resin. The repairs, which restored the structural integrity of the concrete liner, were handled in three phases:

The epoxy adhesive was injected under pressure through openings in the seal. The adhesive is unusual in that it will displace water from a surface as it is introduced, thus ensuring a structural bond. The largest of the radial cracks required 14 gals. of adhesive; the finest (about 0.004 in. wide) took 3/4-gal.

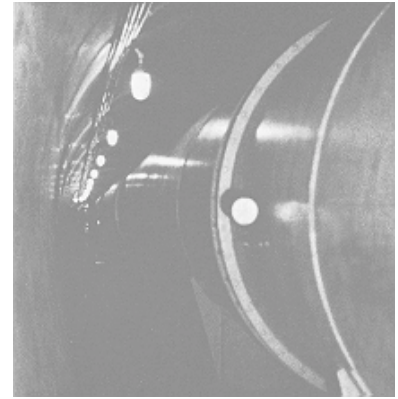
One of the larger structures of its type, the earth-filled dam is 1600 ft. long across a canyon, 220 ft. high and 390 ft. thick at the base.
